INSPECTOR GENERAL

SEPTEMBER 24, 2015

Continental United States Military Housing Inspections – Southeast

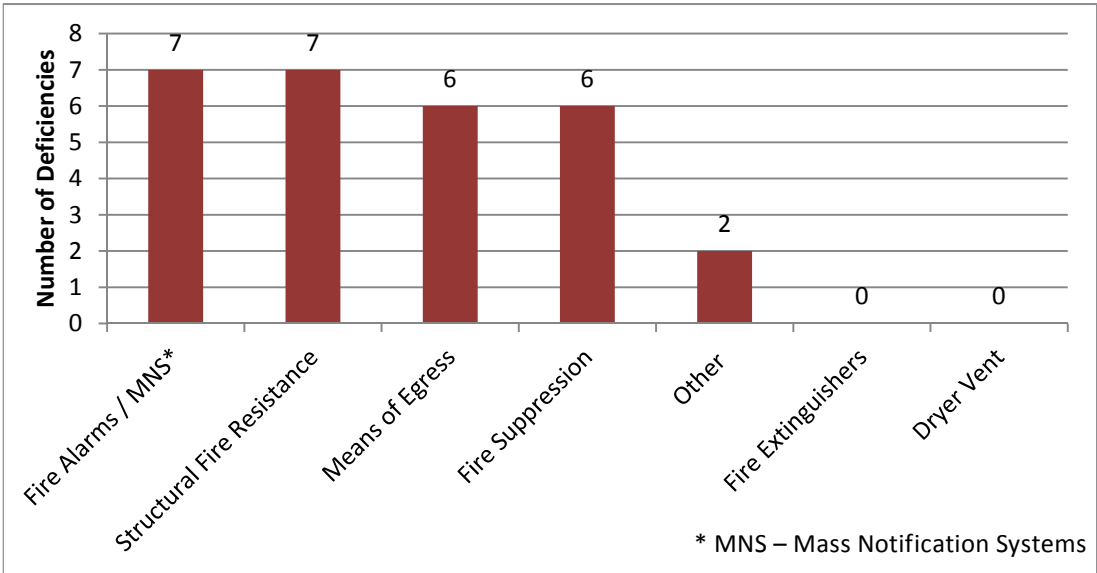
Figure 2. Patrick AFB Fire Protection System Deficiencies by Category

At Patrick AFB, we documented a total of 28 deficiencies (see Figure 2) related to fire protection and fire suppression systems: 17 in family housing units and 11 in the unaccompanied housing building.

The majority of the deficiencies discovered in accompanied housing units at Patrick AFB were related to problems with structural fire resistance, means of egress, and smoke alarms. We found numerous instances of disabled or otherwise ineffective self-closing fire doors separating garages from living spaces, door locks and latches that could potentially trap children in closets and enclosed patios in the event of an emergency, and improperly installed and maintained stairway handrails. Our inspection team also identified that all homes inspected throughout the River’s Edge neighborhood lacked smoke alarms in their bedrooms⁶ in addition to a few issues related to incorrectly located carbon monoxide detectors and

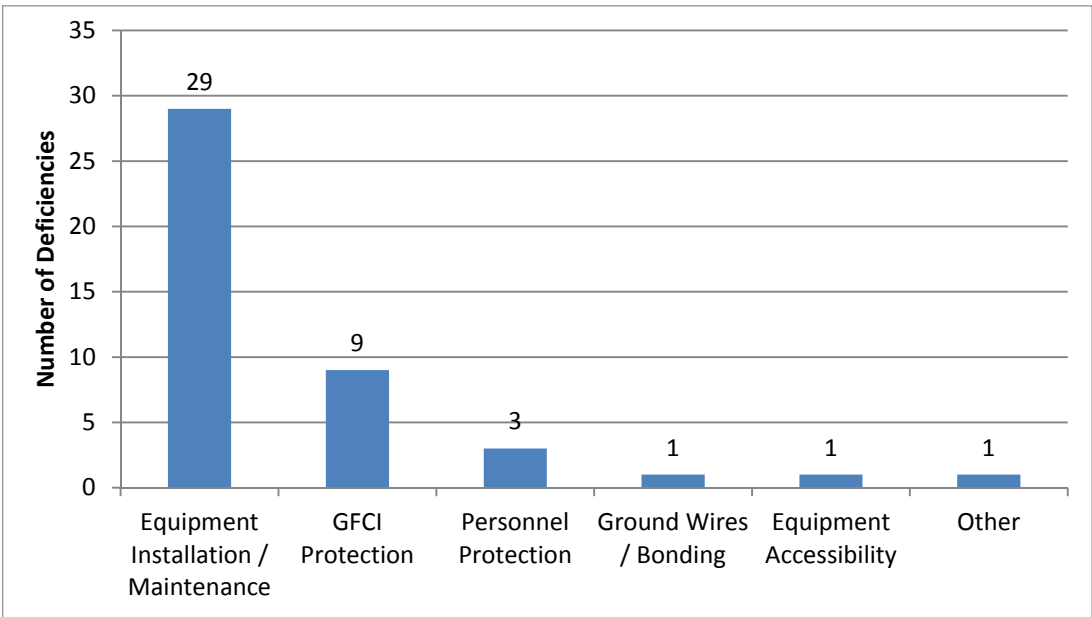
Figure 4. Patrick AFB Electrical System Deficiencies by Category

Our team identified a total of 44 electrical system safety deficiencies (Figure 4) at Patrick AFB: 38 in family housing units and 6 in the dormitory building. The majority of deficiencies found were related to equipment installation/maintenance and ground-fault circuit interrupter (GFCI)⁹ protection.

In family housing units, we found multiple problems with electrical receptacles, including defective wiring, incorrectly secured and loose receptacles, unprotected wall openings,¹⁰ and broken or missing receptacle faceplates. We also identified numerous instances of unsupported, unsecured, and incorrectly terminated wiring and conduit. According to the Electrical Safety Foundation International, arcing faults that result from loose, unsecured, improperly terminated, and corroded

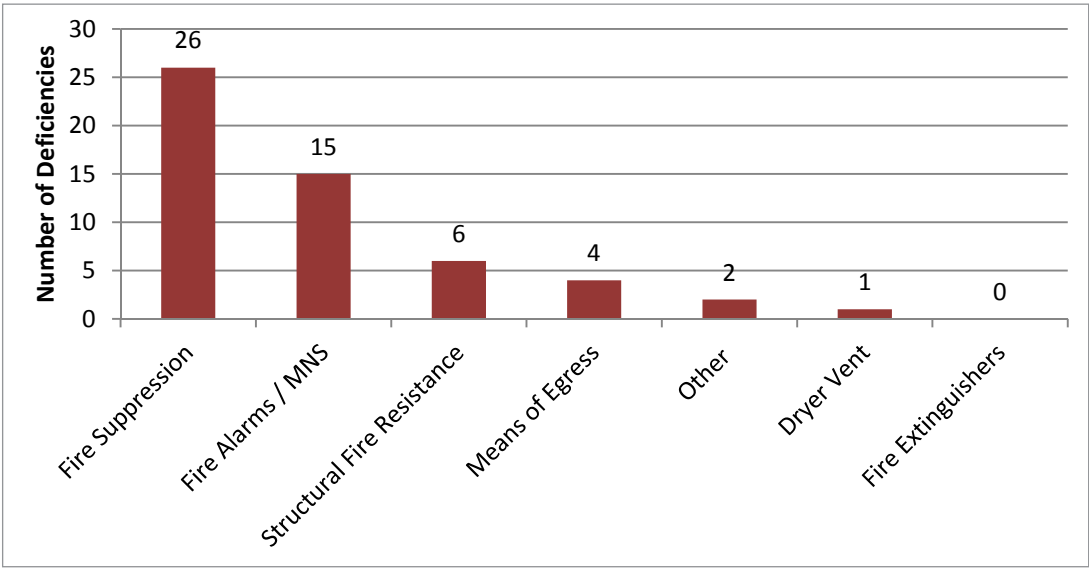
Figure 6. NS Mayport Fire Protection System Deficiencies by Category

At NS Mayport, we documented a total of 54 deficiencies (Figure 6) related to fire protection and fire suppression systems: 11 in family housing units and 43 in the unaccompanied housing facilities (including 1 deficiency associated with the previously discussed NOC).

None of the homes inspected in the Bennett Shores West and Ribault Bay Village neighborhoods had bedroom window openings that met the minimum emergency egress size requirements. Inadequate means of egress may prevent occupants from being able to escape in the event of a fire, leading to injury or death. Based on our observations, it appears likely that none of the homes in either of these two neighborhoods have bedroom window openings that meet the requirements. We also found enclosed second-level patios with doors that cannot be unlocked from within the patio in the Ribault Bay Village neighborhood, which could potentially prevent a person from being able to escape in the event of an emergency. It should be noted that the Navy planned to divest itself of the aging,

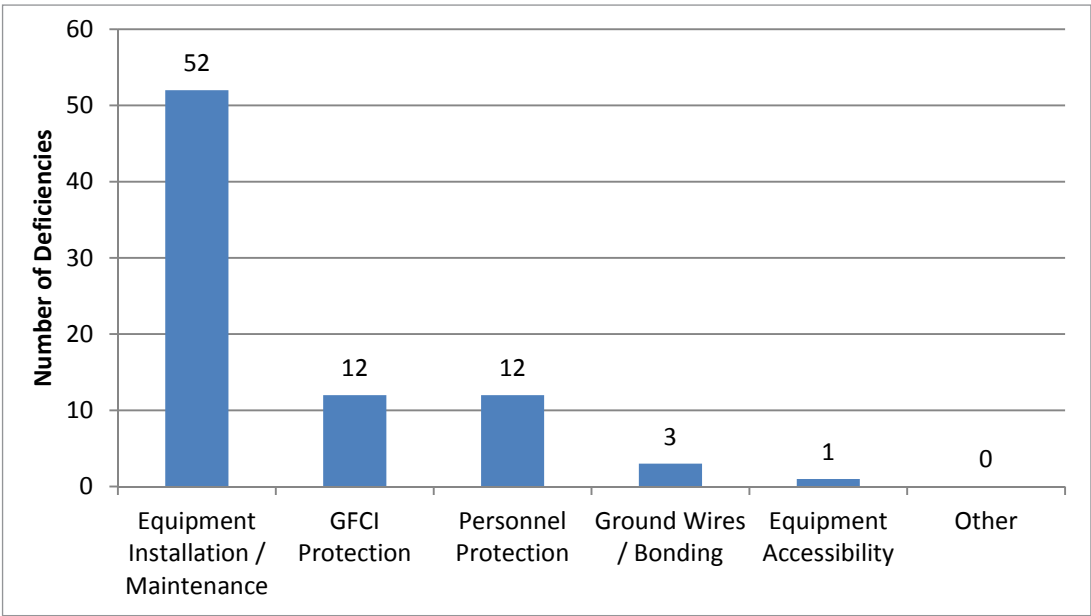
Figure 7. NS Mayport Electrical System Deficiencies by Category

Our team identified a total of 80 electrical system safety deficiencies (Figure 7) at NS Mayport: 35 in family housing units and 45 in the unaccompanied housing facilities. The majority of deficiencies found in both family housing units and the unaccompanied housing facilities were related to equipment installation/maintenance, GFCI protection, and personnel protection.¹³

In family housing units, we found numerous problems with electrical receptacles, including instances of defective wiring, incorrectly secured and loose receptacles, unprotected wall openings, and broken or improperly installed receptacle faceplates. Several electrical conduits and junction boxes were unsupported and unsecured. Additionally, we identified several outdoor electrical receptacles

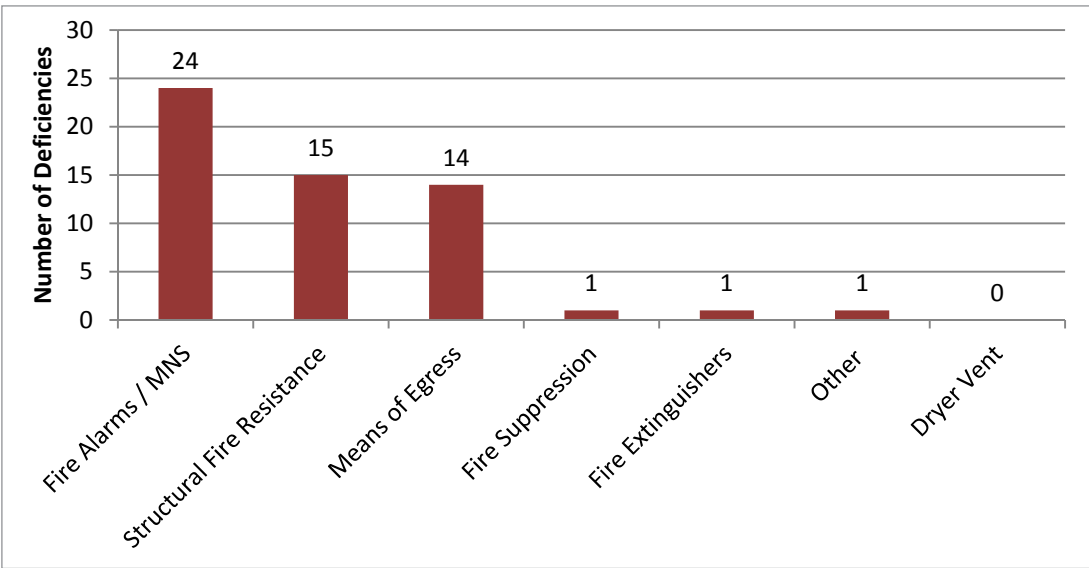
Figure 10. Fort Gordon Fire Protection System Deficiencies by Category

At Fort Gordon, we documented a total of 56 deficiencies (Figure 10) related to fire protection and fire suppression systems: 6 in family housing units and 50 in the unaccompanied housing facilities (including 13 deficiencies associated with the previously discussed NOC).

In family housing units at Fort Gordon, we discovered a few locations that lacked the required carbon monoxide detectors and one home that was missing smoke alarms in all of its bedrooms. We also found a few smoke alarms with dead batteries and disconnected hard-wired power. Inadequate fire alarm and notification systems greatly increase the occupants’ risk of injury or death in the event of an emergency.

In the unaccompanied housing facilities, we also found numerous deficiencies related to fire/smoke detection, alarm, and mass notification systems. For instance, we identified missing, obstructed, and nonfunctional fire alarm system

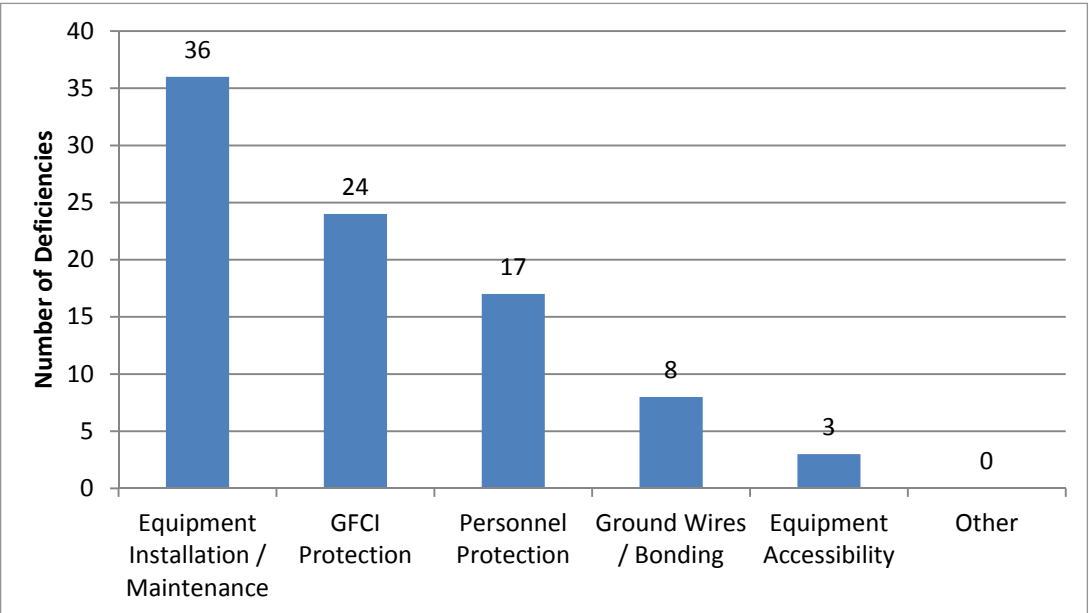
Figure 12. Fort Gordon Electrical System Deficiencies by Category

Our team identified a total of 88 electrical system safety deficiencies (Figure 12) at Fort Gordon: 9 in family housing units and 79 in the unaccompanied housing facilities. The majority of deficiencies found in both family housing units and the unaccompanied housing facilities were related to equipment installation/maintenance and GFCI protection.

The most significant issue we found was the ground conductors on light switches (see Figure 13) were not connected throughout the homes inspected in the Gordon Terrace, McNair Terrace, and Olive Terrace neighborhoods. In the event of a short circuit to the metallic light switch body, the ground conductor would prevent an individual from being exposed to potentially lethal voltages. We also identified problems with electrical receptacles and wiring as well as the lack of GFCI-protected receptacles in the kitchen areas of a few homes inspected.
